# Totally T-Type 2

ISSUE 21 - DECEMBER 2013

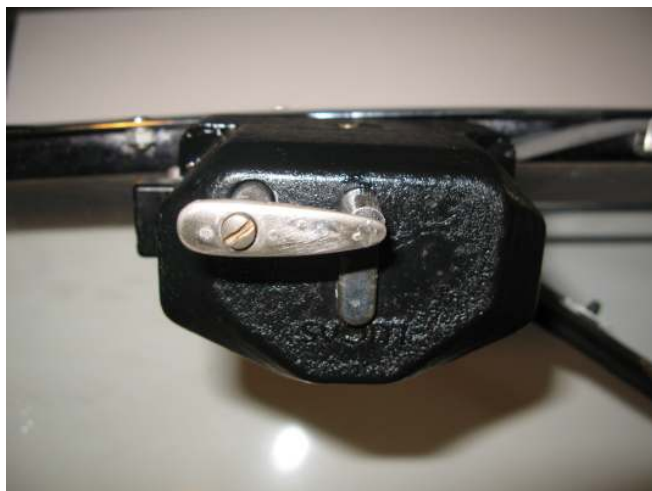
**Photo 1 - The familiar view of the Lucas CWX windscreen wiper motor as seen by the passenger!**

I found that one of two (sacrificial) pins on the main drive shaft spindle (P in exploded view – see later comment) had come adrift and possibly damaged the field coil or the armature coil. I replaced the pin

in the shaft (with a home made replacement!) and the motor ran without load, (i.e. no wipers attached to the drive shaft.) but came to a stop when asked to drive the wipers.

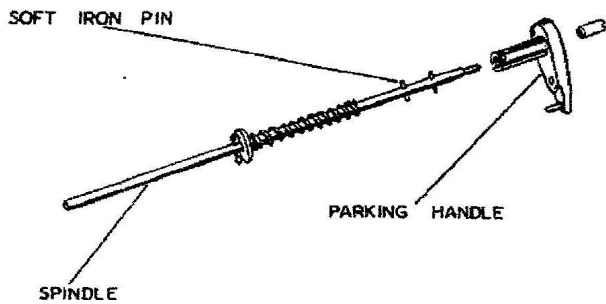
The drive spindle is shown above with the “soft iron” sacrificial pin identified. If this pin is broken it is best to identify the cause before replacing. The original pin can be replaced with a small soft metal “panel pin”, or similar, that must be a tight press fit into the spindle.

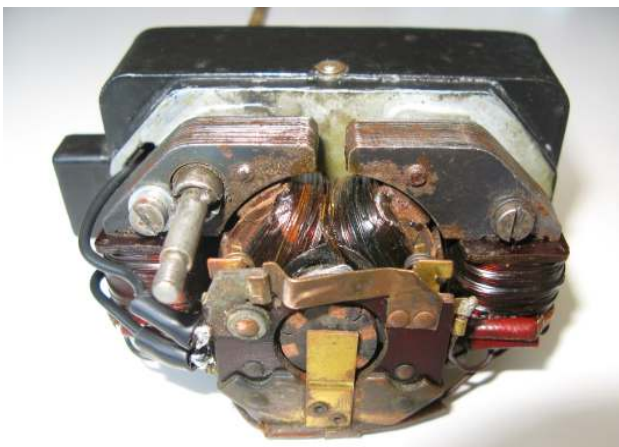
Photo 2 – view from rear of motor after cover removed.

At the rear of the motor (see photo 2) is the brush holder assembly with the brass on/off switch contacts just above the back of the centre of the armature.

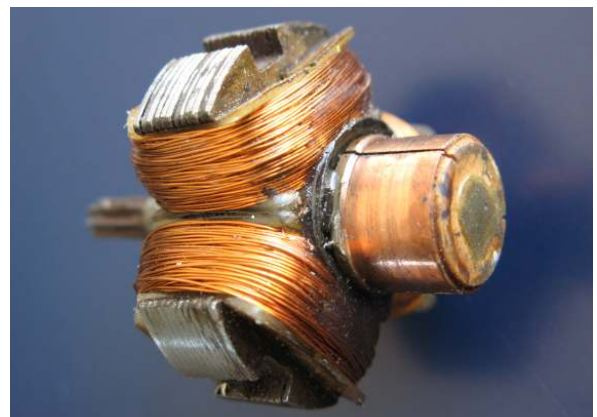
Photo 3 – the armature, having been extracted away from the (front) gearbox and field coil assembly.

The armature should be inspected for signs of excessive wear or damage. It is likely that the commutator will have some signs of wear but this may not be significant enough to warrant replacement.

I found a break in one of the armature coil windings that would account for my wiper motor failing. Although this item is typically classified as "not available" from most parts suppliers, it is still possible to purchase a new armature (with new brushes) from "Complete Automobilst, Vintage Supplies Ltd" in Norfolk. [www.completeautomobilst.com](http://www.completeautomobilst.com) Phone. +44 (0)1692 406465.

I should add that this armature comes with two new brushes and although I believe these brushes last a long time it is worth replacing these at the same time.

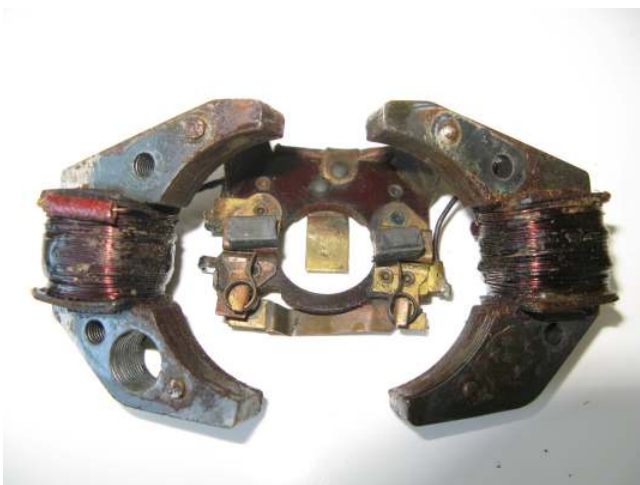
**Photo 4 – the two field coils**

Check the integrity of the field coils with an ammeter. Each of the coils has a resistance in the region of 8 or 9 ohms with a combined total of 18.5 ohms, in my case. However the most important

A repair is an option for the field coil if it has suffered some "contact" damage with the armature, (or a loose drive shaft "soft iron pin" as in my case!). The coil is typically, but not always, covered and protected with a fine linen "bandage", wrapped tightly around the wires. If the linen covering is damaged, along with the wire, it is possible to remove the bandage, and expose the wire coil to identify any break in the outer windings. Once identified the two damaged open circuit ends of wire may be cleaned and a short length of shellac removed to enable soldering. The ends should be dipped in soldering flux before re-soldering. It might be necessary to "insert" a very short length of fine wire between the break as the coil is typically very tightly wrapped. Once the solder repair is complete, test for the correct 8 ohm resistance of the affected coil, and then re-tape the coil with linen insulation as before.

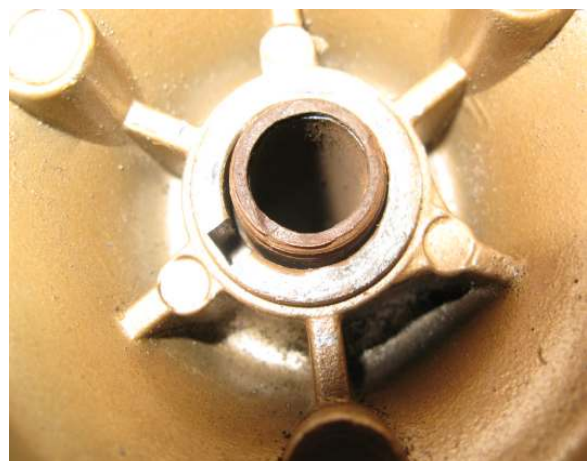
On my TD's recent Garage "vehicle safety check" it was noted that the steering column had play in the upper felt bush that fits between the steering tube and the column shaft. The worn bush exhibits a certain amount of movement at the top end of the column, most easily detected by gripping the steering wheel and applying up and down pressure on the column axis.

**Photo 1 - At the top of the exposed upper end of the column is the bush (Felt) that wraps around the shaft inside the column itself.**

It is necessary to "pick" out this old felt from the end of the column. This is best done with a piece of wire (paperclip?) or a small thin screwdriver. Be sure to withdraw all the felt as it can be dry and liable to disintegrate depending on age.

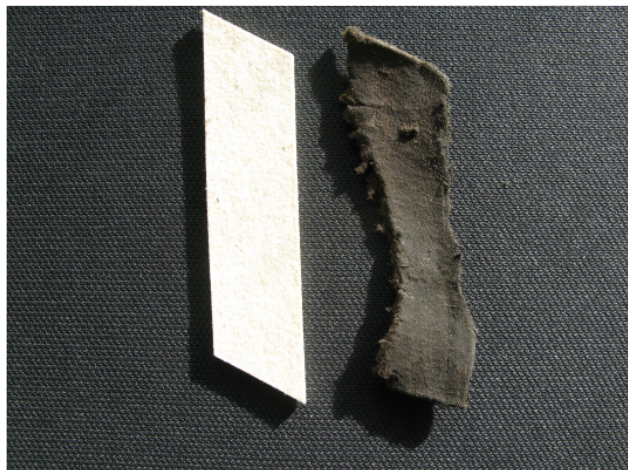
**Photo 2 - The New and Old felt bushes show why replacement was necessary!**

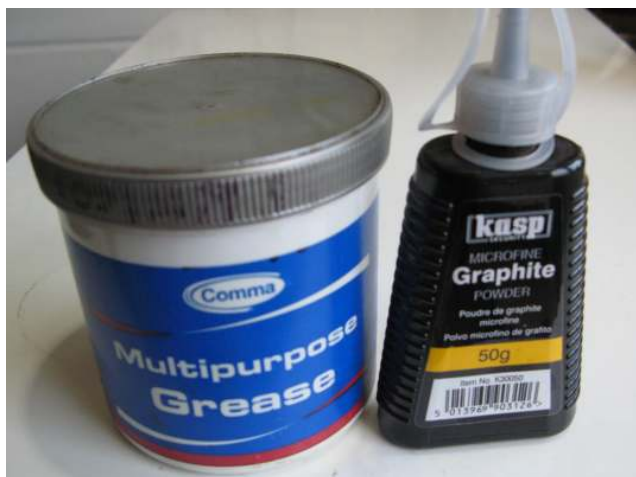
**Photo 3 - The Workshop Manuals say that the inner face of the felt should be coated in Graphite Grease to provide the necessary lubrication between column and shaft.**

Mix the required small quantity of grease (two level teaspoons full should suffice) with a liberal quantity of graphite powder and stir well to create a heavy Graphite grease constituency. Do not add so much powder so that the resulting constituency is dry.

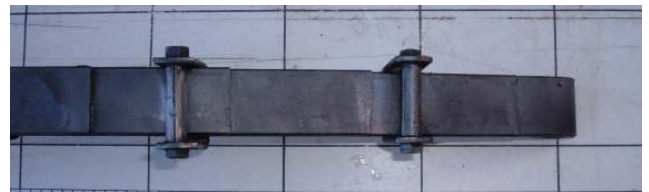
Most new springs have the ends of the leaves chopped off square. Original spring leaves had their ends tapered and chamfered to prevent the ends digging in to adjacent leaves. Judicious use of an angle grinder could help form an original profile after the springs have been dismantled.

**Photo 1** – an after market PA/PB spring with its leaves chopped off square.

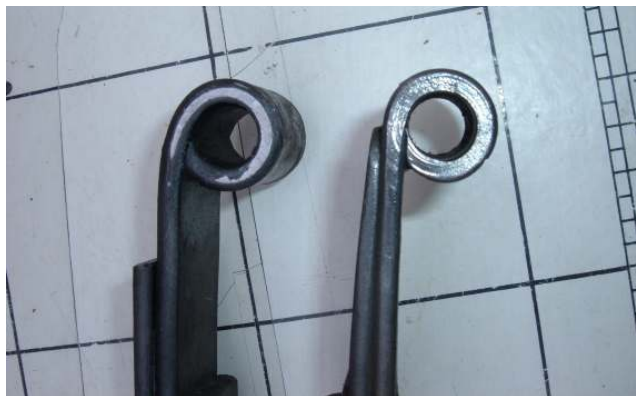
Modern front springs seem to suffer from poor quality control, the front eye being badly formed and consequently a loose fit on the pin.

**Photo 3 – comparison of ‘eyes’ at the front of the spring; the spring on the left is an after-market PA/PB front spring; the one on the right is an original TC front spring. Although perhaps difficult to spot, the ‘eye’ of the spring on the left is slightly out of round, whereas the one on the right is perfectly round.**

A rolled up strip of 7 thou. bronze shim can be used to “pack out” the eye using between 2 to 4 turns. Suitable shim is available from Noggin End Metals, [www.nogginend.com](http://www.nogginend.com) at approx. £2-50 a pack. (see item under ‘Bits and Pieces’).

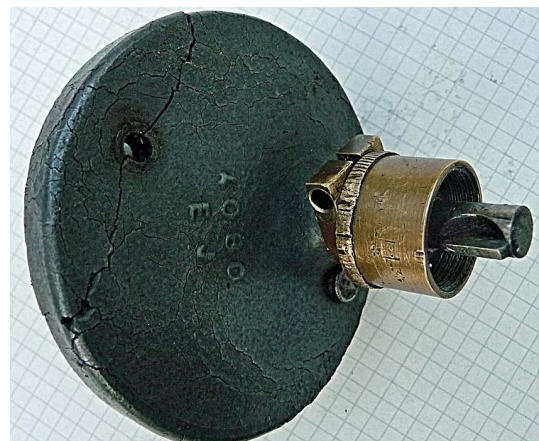
**"Before" - with badly cracked casing**

First of all I had to super glue the bits together to get a more accurate idea of the sizes and position of the fixing holes. The aluminium was turned up as pattern and the whole thing bolted together, it has been working now on the car for some months now with no problem.

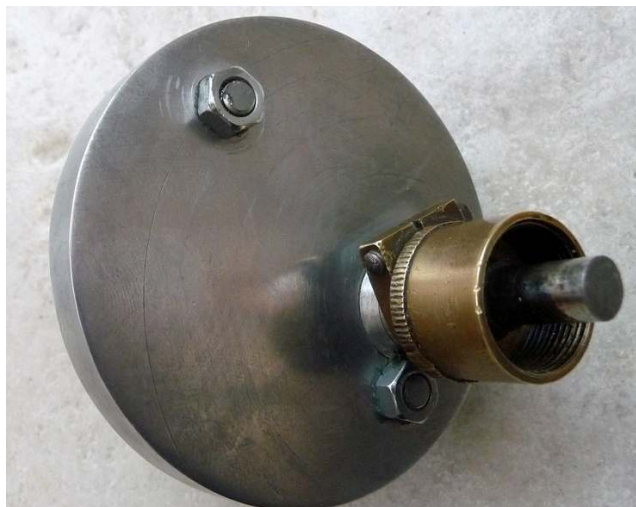
“After” – now expertly repaired

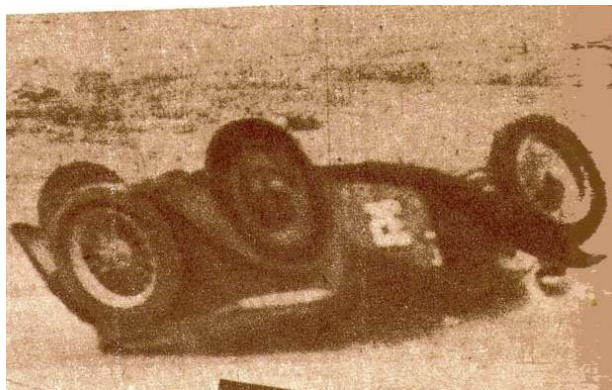
Marco Di Paolo e-mailed this photograph of a crashed TC. The accident occurred at the inauguration of the "Autodromo de la ciudad de Buenos Aires" (the motor racing circuit in Buenos Aires) in 1952. The driver, Felix Martinez was killed.
