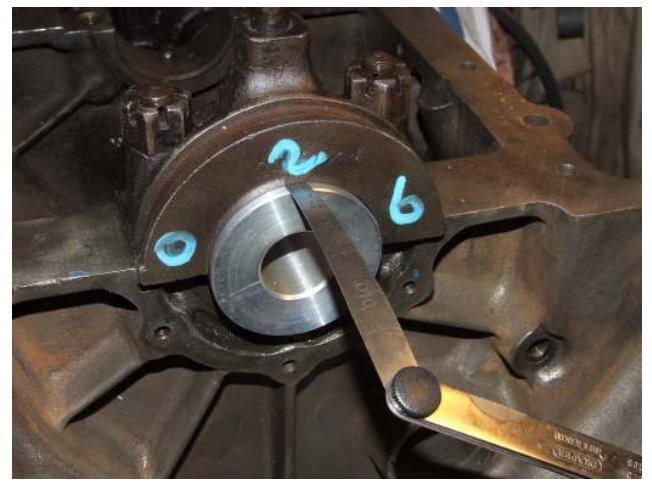
This revealed that Roger may have been optimistic when he suggested that "The oil scroll housing on the rear main bearing cap will have a uniform clearance all round as it was bored in line with all the main bearing housings". In this particular block I measured 0.006" clearance on one side, gradually diminishing to less than 0.001" on the other (*Photo 1*).

Photo 1 - Feeler gauge inserted between housing and setting gauge

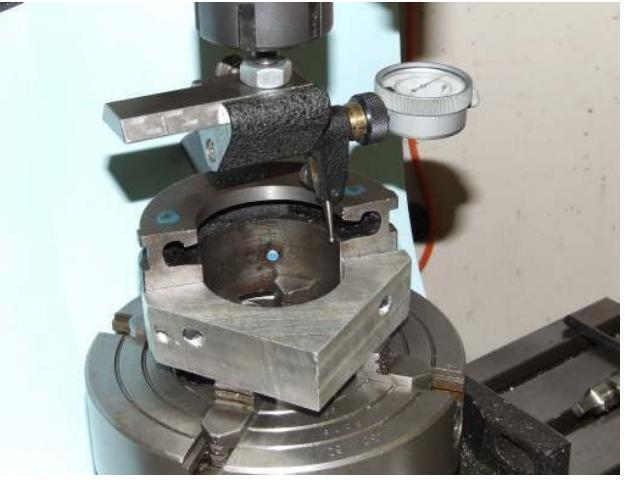
My first thought was that the setting gauge was not seating properly, so to eliminate the gauge, the rear main bearing cap was mounted on a mill table and a Dial Test Indicator mounted in the chuck was then used to check the concentricity between the oil scroll housing and the shell bearing housing *(Photo 2)* This confirmed the 0.006" misalignment.

Photo 2- checking the housing with a DTI

A magnified inspection of the oil scroll housing's surface suggested that some rubbing against the crankshaft's oil scroll had taken place. This leads me to believe that wear in the main bearings could have been considerable, thus allowing the crank's oil scroll to contact the housing.

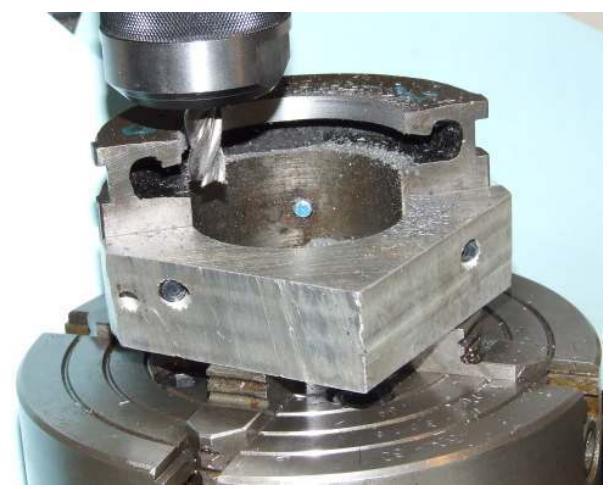
Photo 3 - Machining the housing

Rather than have the main bearing cap line bored, I chose to machine the oil scroll housing to be concentric with the bearing housing *(photo 3)* and set up a uniform gap of between 0.01" and 0.015".

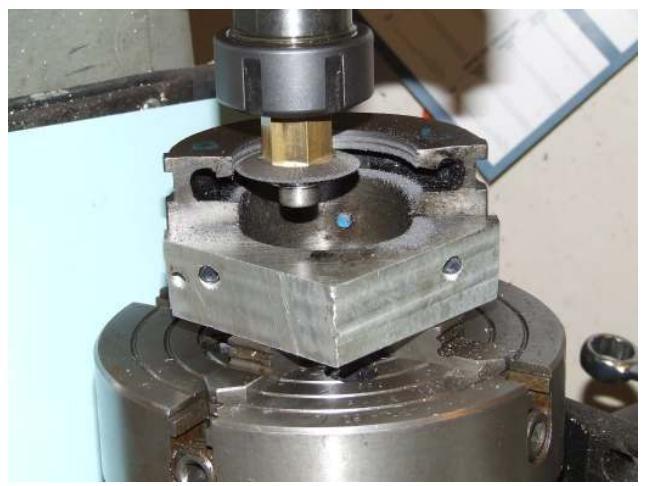
Photo 4 – machining the groove

On dismantling, the sellotape is removed along with any excess JB Weld. Such an approach should set up a truly concentric gap of about 0.002" (0.05mm). The extra clearance machined on the oil scroll's housing allows a thicker, more robust layer of JB Weld and to improve adhesion a groove was also machined into the scroll's housing *(Photo 4)* with a slitting saw.

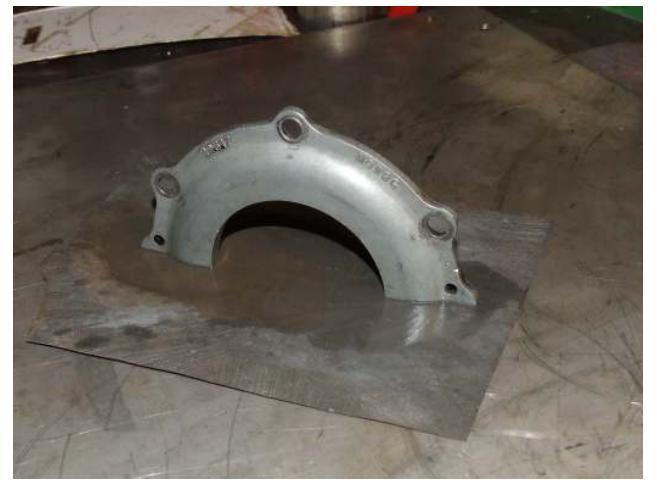
Photo 5 – skimming the cap's flat edge

Using the gauge, a gap of 0.004" at the top of the slinger cap and a tight fit at the sides was revealed, suggesting a new cap had been installed. A light skim of the cap's flat edge on some 320 wet and dry *(Photo 5)* and some judicious scraping (Photo 6) set up a uniform 0.002" clearance with the gauge.

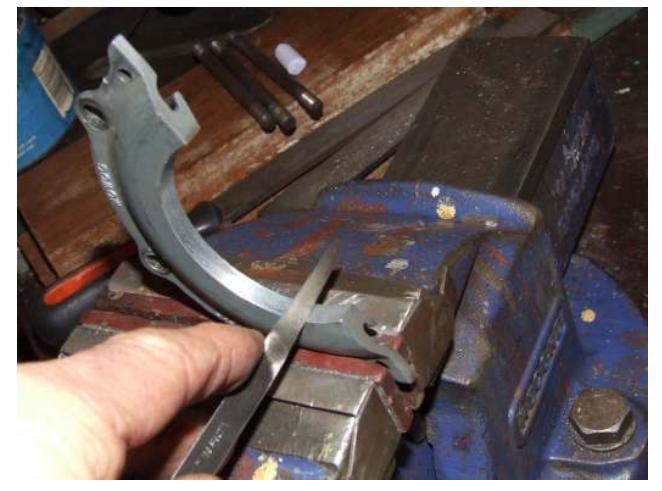
Photo 6 – scraping the cap's surface

cap's location in the absence of the pins once the cap has been secured by its three screws. The use of some 0.002" shim steel wrapped around the gauge would help true the fixing of the slinger cap to the block.

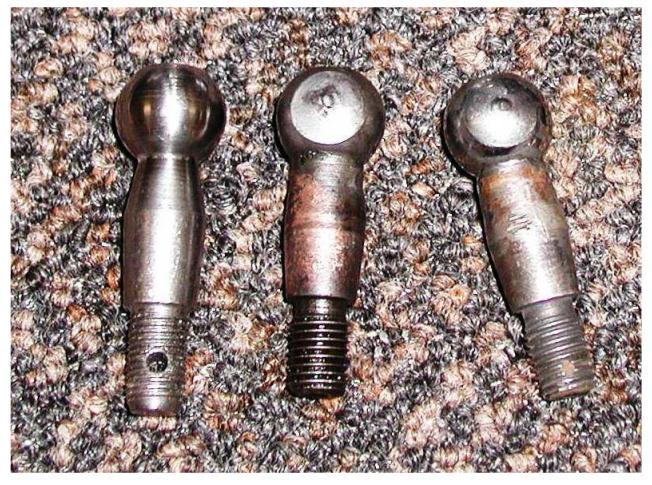
**Inspection:** Finally, what do you look for when inspecting? The obvious answer is looseness. Jack up your car and give the steering a shake. If there is any sign of end play, it's time for inspection. Common fail items are broken internal springs. And if you don't keep it lubricated the balls will wear as in the photos, causing steering issues. Most importantly, DO NOT trust the assembly order from the prior owner. It is not uncommon to find it wrong, which has created many of the problems mentioned above.

Two examples (on the right) of ball joint wear

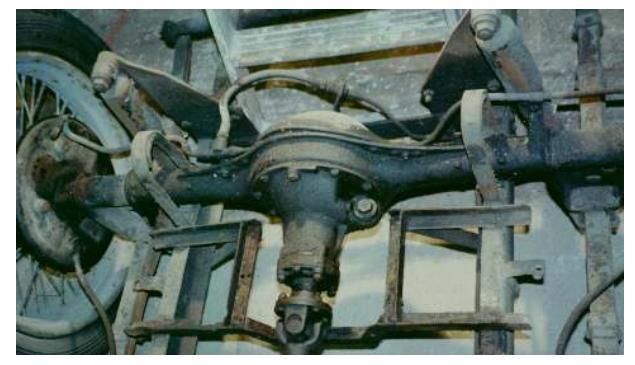
Photo 'A'

#### Photo A shows the back end of the chassis; note the telescopic shock absorber conversion and the prop shaft fitted in the wrong place.

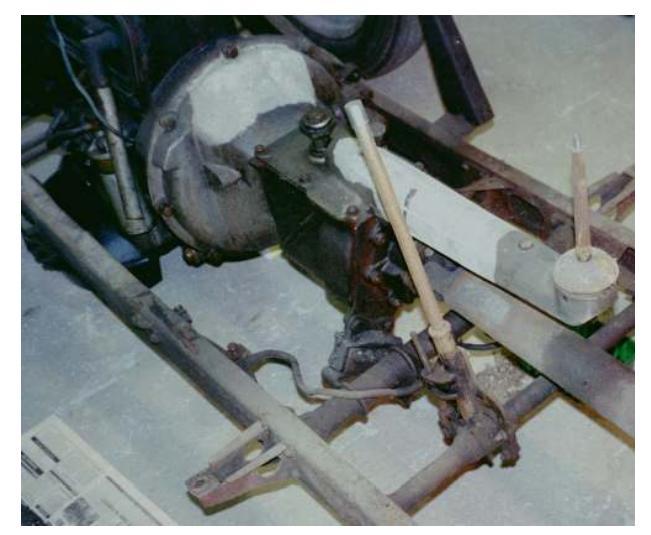
Photo 'B'

The battery supports were very corroded. The hand brake and gear lever were rusty.....**Photo B**. The handbrake lower pivot was very loose and its cross tube was loose at the ends. The chassis was fitted with small aluminium cased shock absorbers, they were seized solid. The front springs were different sizes and the front axle bent. **.Photo C**.

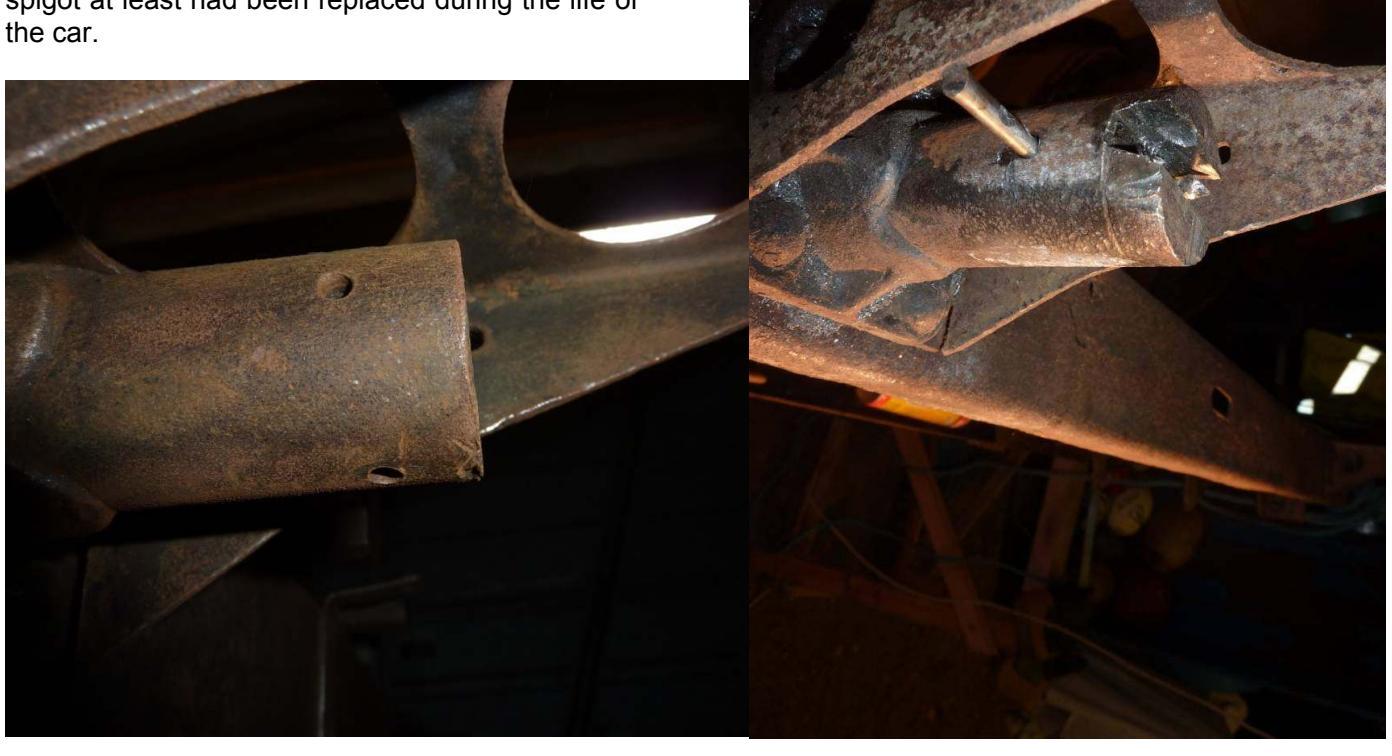
After removal I noticed that the cross tube had 2 small raised areas showing on the outside which had not been visible before. These turned out to be metal plugs which filled 2 holes in the tube at right angles to the pin position – see photo 1, i.e. horizontal, where, clearly, another taper pin had previously been. I assumed from this that the original pins were placed horizontally and that this spigot at least had been replaced during the life of the car. The off side had no visible pin showing despite cleaning up and using a magnifying glass to try to identify any blemish or mark to give me a clue. Was the pin vertical or horizontal? I decided that the only way to determine the location of the pin was to cut off the spigot and drill into the remaining metal to expose the pin inside the tube but leaving the flatted section so that the spanner could be used later to remove the remains. After a bit of sawing, angle grinding and drilling I could see inside the tube.

PHOTO 1 – Near side showing original and later pin positions.

The result of this was that the pin was horizontal, which was to be expected from what I had found on the near side. With careful measurement I marked the pin position on the outside of the tube, made an intelligent guess about which way it tapered (I could see it inside the cross tube using a torch but the taper is not easy to see) and with a hammer and drift knocked it out. It was surprising that this pin was initially invisible from the outside and one must assume that these were ground off flush with the cross tube as part of the manufacturing process.

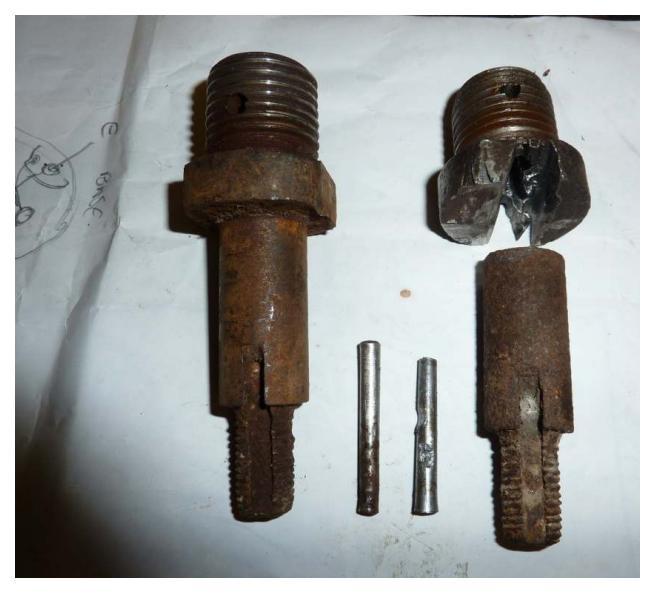
Interestingly both threads on the spigots where they go into the cross tube were clean and shiny. I expected water penetration to have rusted these over the years – see photo 3.

PHOTO 3 – old spigots removed

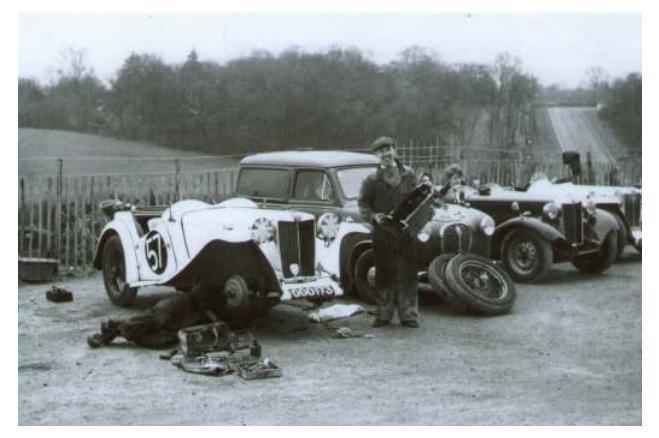
"The picture taken at Brands Hatch in about 1961, shows the result of running with radiator muff still in place and 7000 revs coming down the hill from Druids. The engine expired at Clearways. However the MG managed to get back to North London but of course required a major rebuild.

On strip down it was found that the engine had seized and if I remember correctly a con rod was bent. The bore was found to be at maximum so liners would have to be fitted.
