Totally T-Type 2

ISSUE 23 - APRIL 2014

Welcome to Issue 23, April 2014.

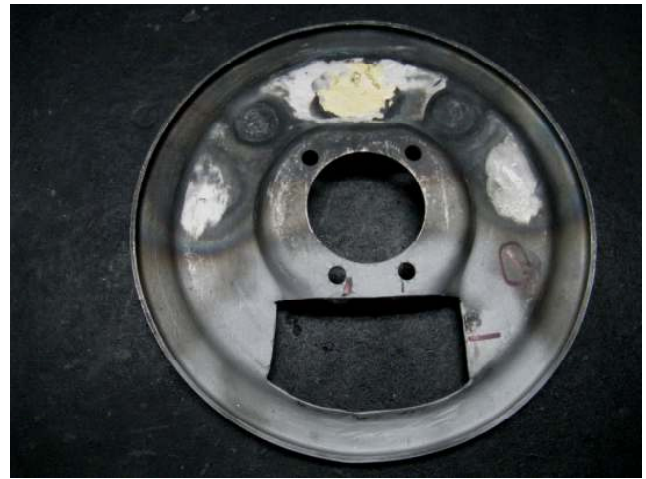
The TC backplate after 'surgery'

This project is all about minimizing the amount the plate warps when you weld in the replacement piece after cutting out the raised portion at 6 o'clock and figuring out the best way to straighten the plate in a hydraulic press after welding. Going at this completely cold, I fumbled my way through the first plate, a lot easier for the second and the next time around should be a piece of cake as I feel I now have the job pretty well figured out. (those famous last words!)

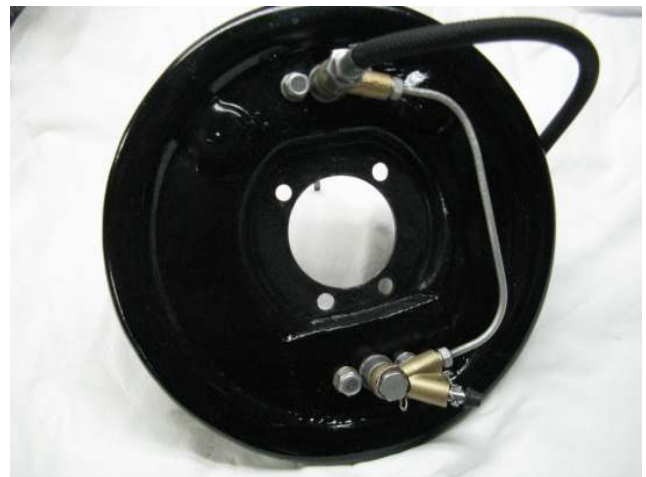
The modified TC backplate

Ed's note: Andy King offers a kit for TA/B/Cs using your existing backplates and modified to take twin leading shoes as fitted to the TD/TF. The kit contains all new wheel cylinders, shoes, return springs and will bolt directly onto your existing drums. PRICE IN THE REGION OF £750.00

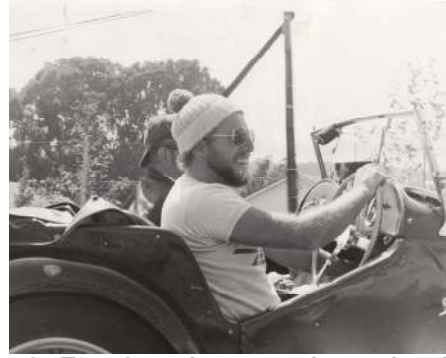
Finally, it broke a half-shaft and, upon inspection, diff oil was found to be leaking into the back drums; steering was now half a turn free play and the brakes worked sometimes! The car was put on blocks and its licence kept valid.

Photo 2 - Tony kept the car on the road until one day a halfshaft broke and it was laid up.

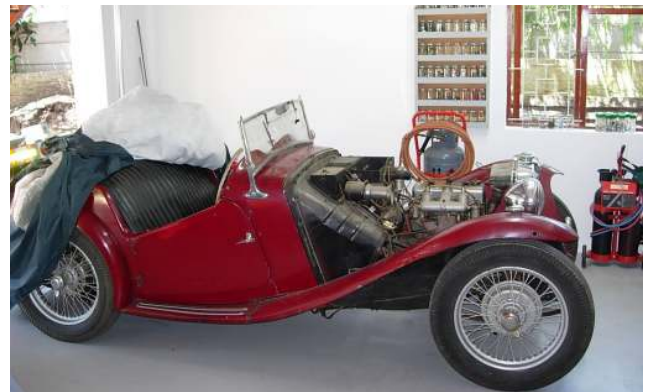
Photo 3 – the start of strip-down. The car looks cosmetically OK - “beauty is but skin deep!”

The chassis had been badly abused and critical parts were missing. Various club members as well as Mike Allison in UK provided important detail and parts and the whole assembly was finally sand blasted and I spray-painted it in the driveway!

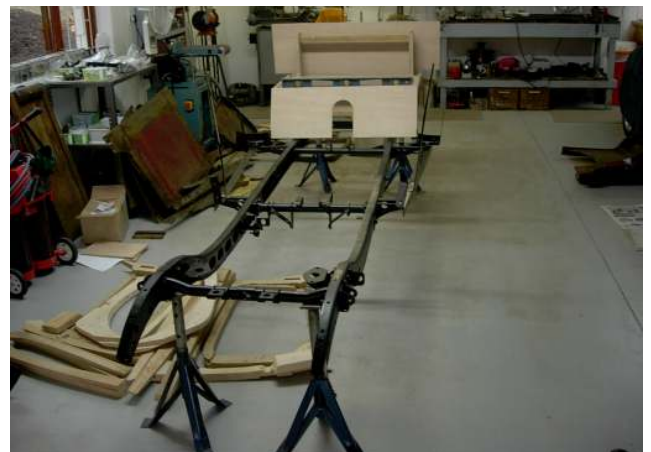
Photo 4 – the restored chassis.

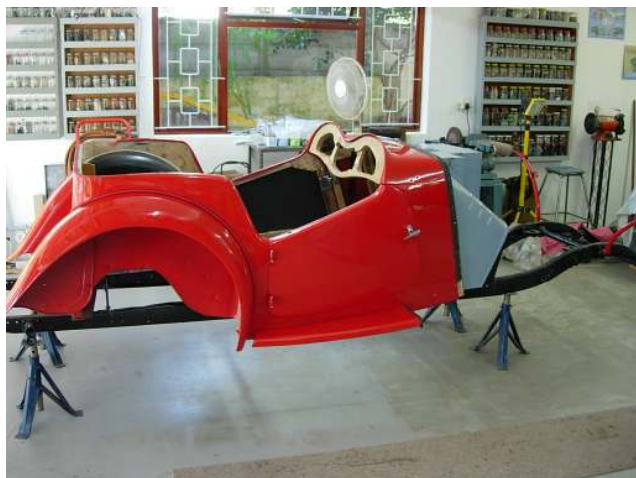
The engine, gearbox and differential were all fully overhauled and painted, ready for final assembly into the car. Steady progress was made over the next three-and-a-half years! The body went back onto the chassis and then all the brake pipes were remade and installed.

Photo 5 – the body now back on the chassis.

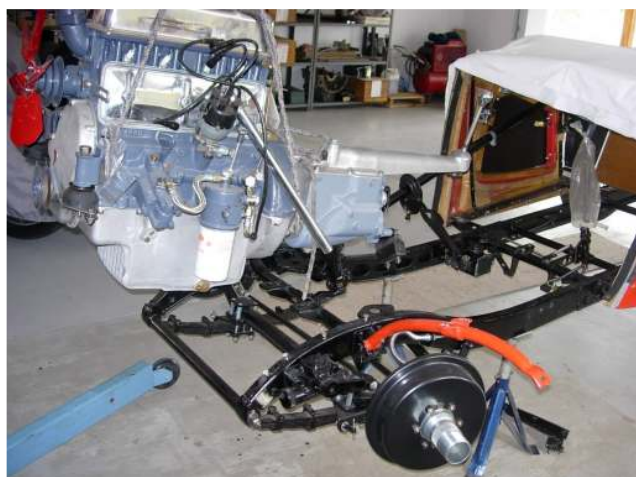
Photo 6 – the engine/ gearbox ready to go in

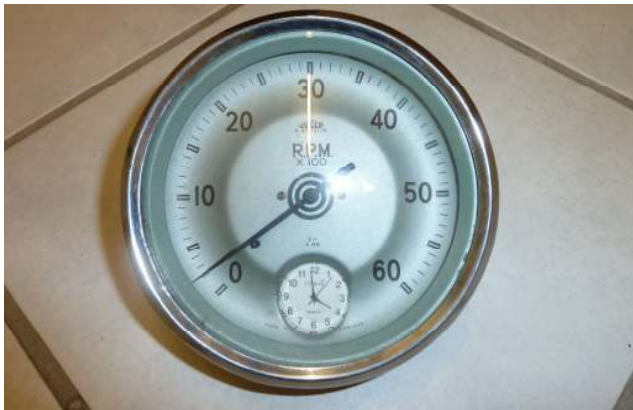
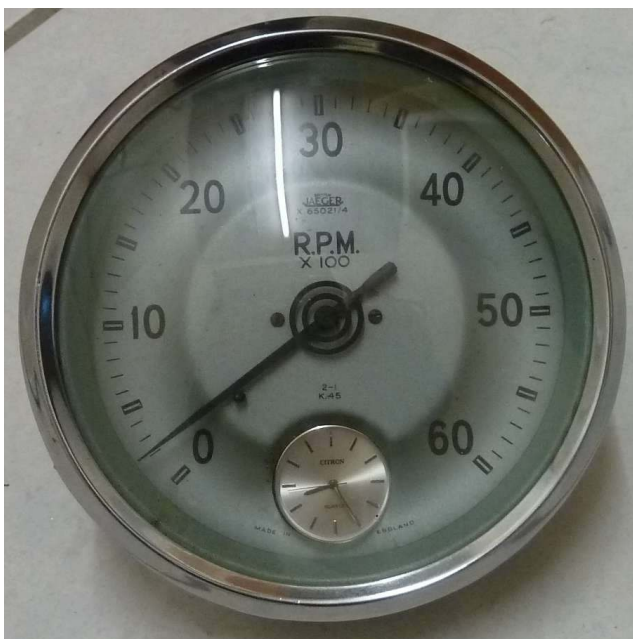
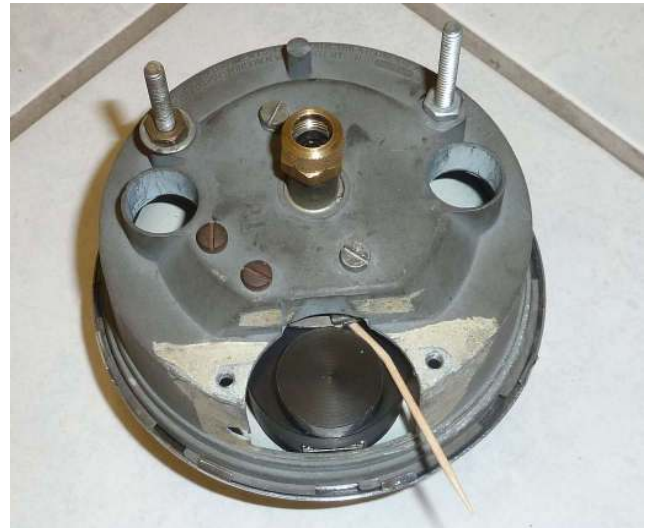
"We all know the problem with the TD clocks. I have made a small batch of replacement clocks for the dish faced speedo on the TD. The problem being a constant sourcing of the ladies watches - they are all different diameters and thicknesses. The mounts are made from PVC and the watch is a click fit.

Once installed, you can only see the face of the clock and not the mount. The battery lasts about two years depending how long the watch was lying on the shelf in the novelty shop! I have attached a few photos. The last photo shows the clock being centred on the speedo. It fits using the original self tapping screws and with a short screw driver it only takes a few minutes to install."

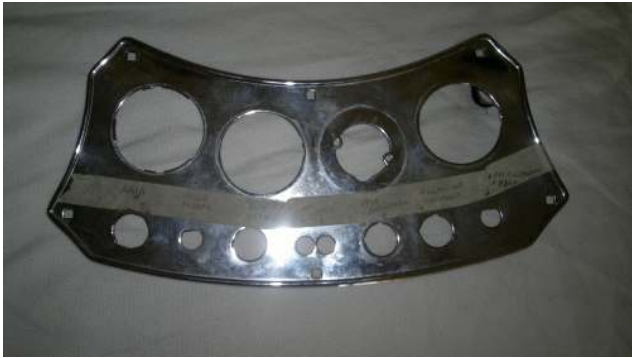
Photo 1 – the 'bare' panel.

Having carefully studied a finished centre panel he planned, copied and calibrated the project with a CAD. Then, with the help of a friend, who deals in publicity materials, he printed it out on a self adhesive foil. The entire sheet is in self adhesive black with the lettering printed in white, so there is no possibility of detachment of the letters. The adhesive is then polished to closely match the original finish of the centre panel.

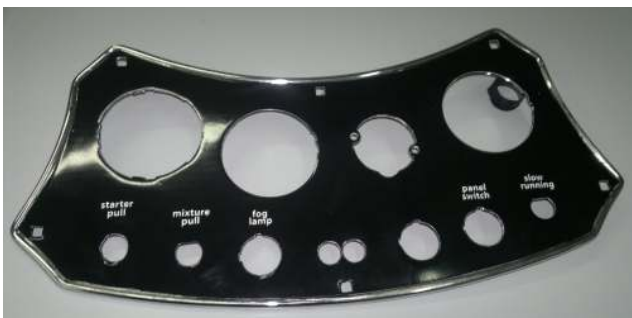
Photo 3 – the finished centre panel – *magnifico!*

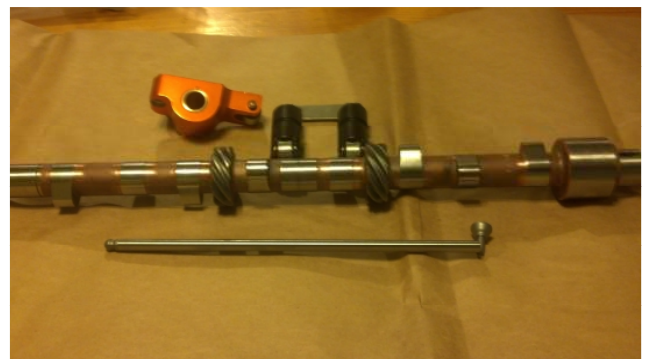
Photo shows – a cam kit with rocker.
