# Totally T-Type 2

ISSUE 20 - OCTOBER 2013

# Keeping it on the straight and narrow – Aspects that affect steering.

# MG TD Fuel tank sensor leak

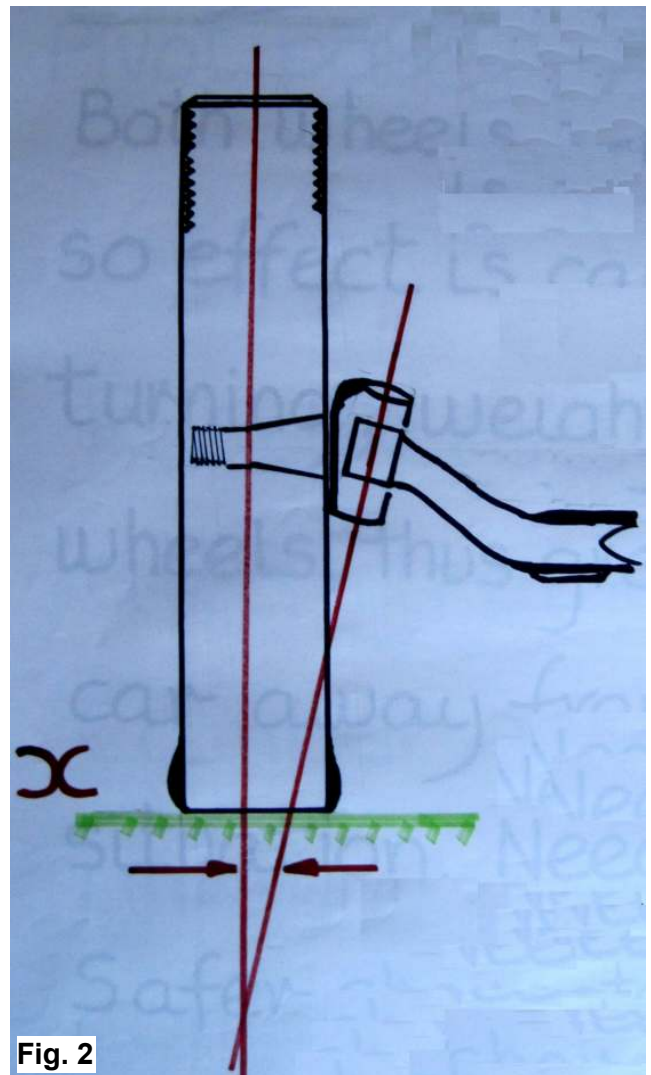
Fig. 2

On the TA/B/Cs, positive offset is used, such that the centre line of the wheel meets the kingpin axis just below the road surface, the offset being given as X. This has disadvantages because the wheels tend to splay outwards as the car moves forward

due to the centre line of the wheel being outboard of the kingpin axis. This would result in heavy steering but for the balancing out effect of both wheels.

A TA with side laced wheels has a reduced offset X which should improve its steering characteristics particularly in the case of unequal tyre pressures. As one front tyre deflates, the positive offset will increase causing the car to veer to that side especially when braking.

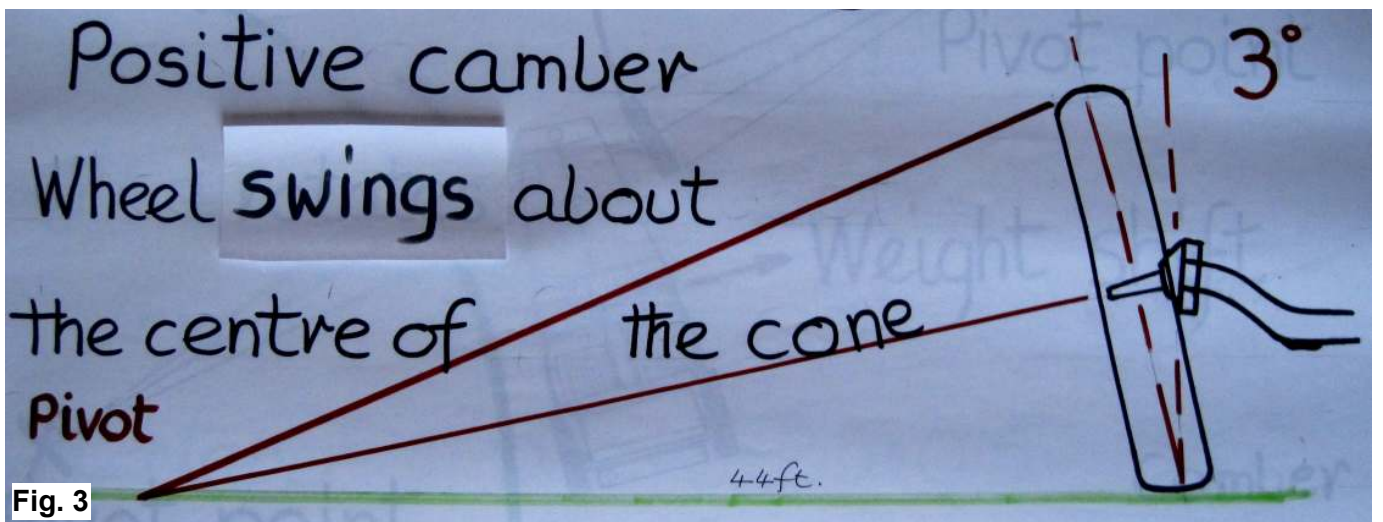
Fig. 3

If the axis of the stub axle is projected to where it would contact the ground (Fig 3) and the two radii from this pivot point to the top and bottom of the tyre are drawn, a cone is formed.

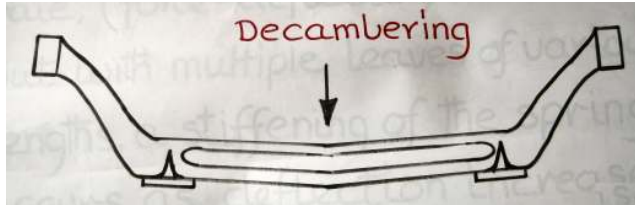
TA/B/Cs set up for competition are sometimes de-cambered by bending the centre of the beam axle (fig 6). This can be achieved by using a hydraulic press (photo 1) A de-cambered axle will have inclined spring mounting pads and these must be compensated for by suitable wedges so that the spring's eye is aligned with the front eye's locating pin.

**Figure 6 – an illustration of a de-cambered axle.**

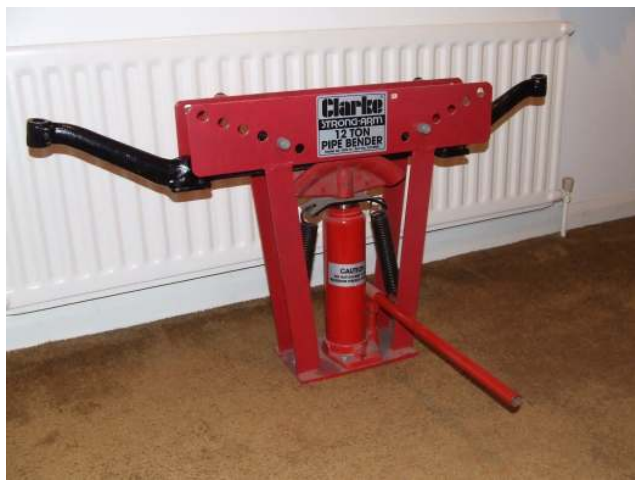
**Photo 1 - a bit of 'metallic torture' to de-camber the axle.**

Some distortions can be corrected by using an hydraulic pipe bender (*photo 1*) or clamping part of the axle to a substantial concrete base with anchor bolts and then using a long rigid lever clamped to the axle, to twist the axle section between the mounting pads back to alignment. These operations should be performed with the axle in its "cold" state.

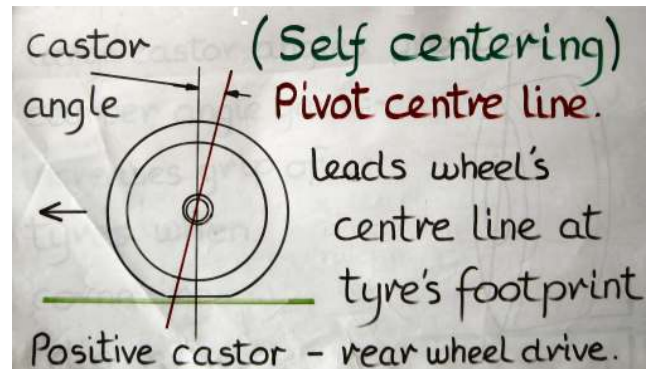
Castor enables the driver to “feel” the straight-ahead position due to the self-centring action of the castor angle. Fig. 8 shows how the pivot centre line of the wheel intersects the tyre’s footprint ahead of the centre of contact.

**Figure 8 – showing the self-centring effect**

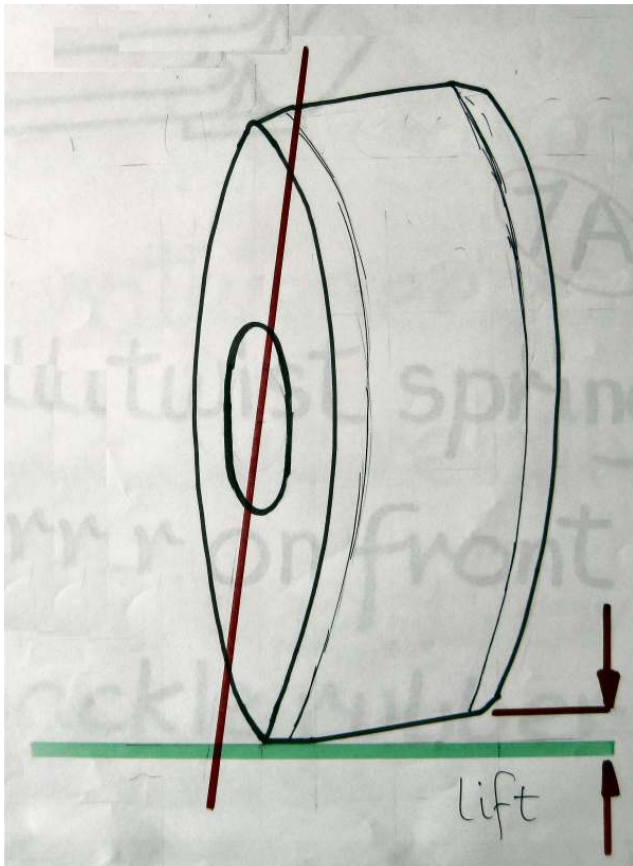
Turning the wheel about the pivot axis results in an edge of the tyre lifting up the wheel (see Figure 9); this can be illustrated by holding a tin can in the hand and holding one’s arm vertically with the can resting on a table. Swivelling the can about the centre axis of one’s arm produces no reactive effect. However, inclining one’s arm to the vertical and swivelling the can should cause one edge of the can to lift.

**Figure 9 - Turning the wheel about the pivot axis results in an edge of the tyre lifting up the wheel.**

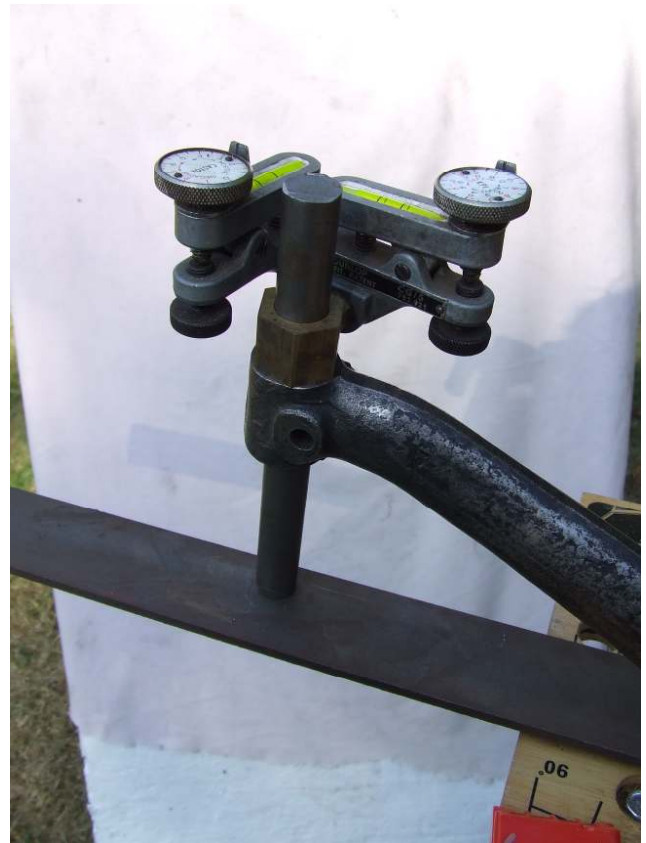
**Photo 2 – checking the castor angle with a special Dunlop gauge; this can also be used to check the kingpin inclination angle**

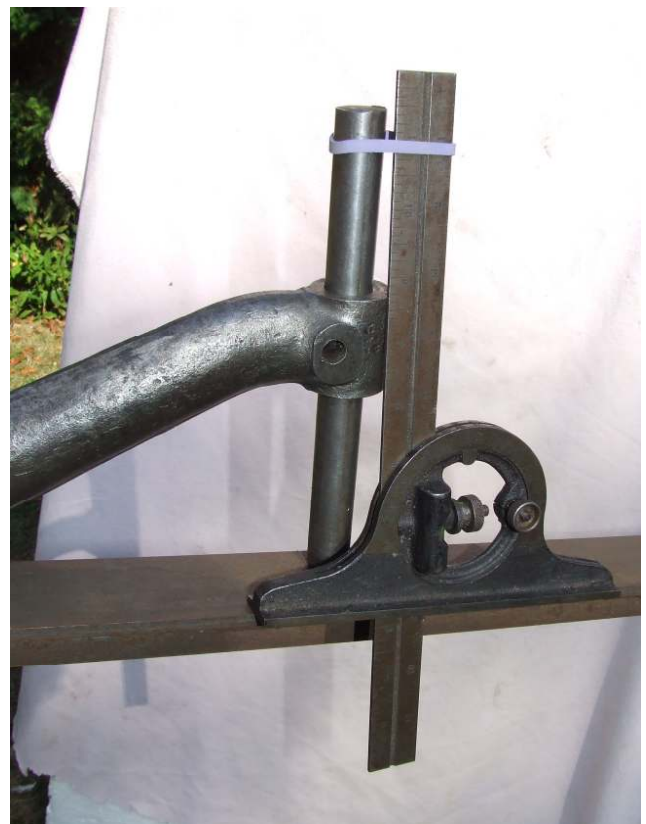
**Photo 3 - checking the kingpin inclination angle with a protractor; this can also be used to check the castor angle**

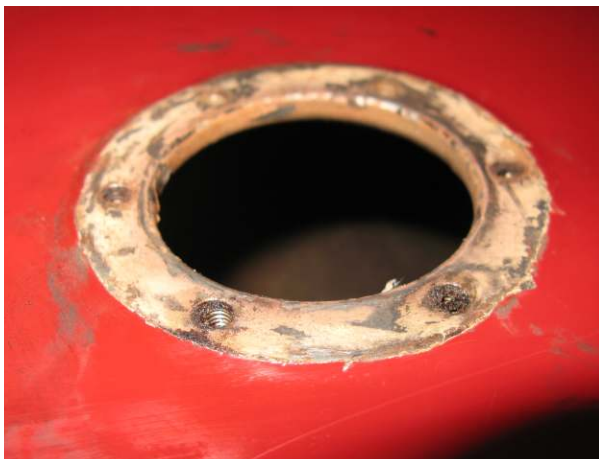
The vertical hole, towards the lower bottom of the back of the tank, where the cork washer fits, needs to be cleaned ready for the new replacement.

Take care to guard against foreign bodies entering through this hole otherwise the tank might need to be flushed out.

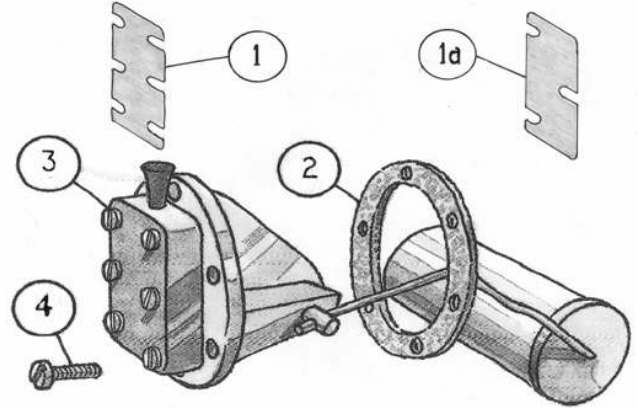
Sender unit components:

1. Paper washer 6 hole.
- 1a. Paper washer 3 hole
2. Cork gasket for sender unit
3. Cover fitting plate / Sender unit
4. Six screws for sender unit to fuel tank.

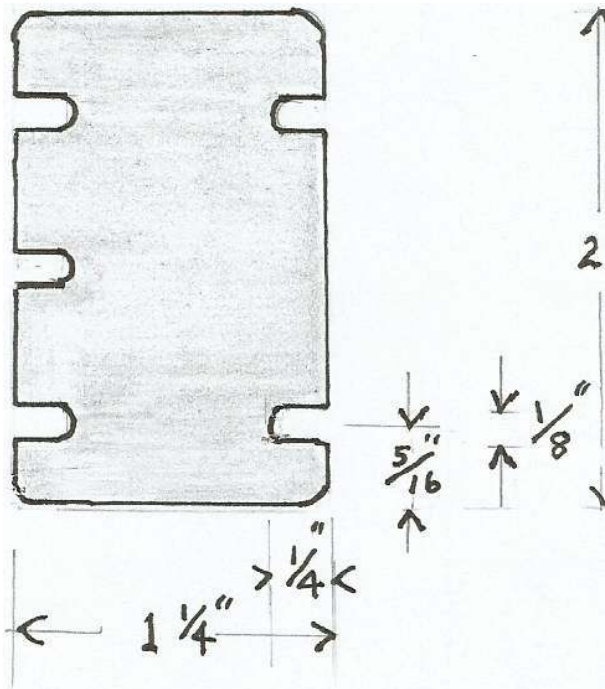
The fuel sender gasket is made of heavy weight drawing or cartridge paper. The size of the gasket is given in approximate inch dimensions but you can always take your metal cover plate to use as an exact former.

**Note.** As the early cover plates were just a 3 “hole” design and later ones had six holes, the drawing may be used as a dimensional guide to either of these two configurations.

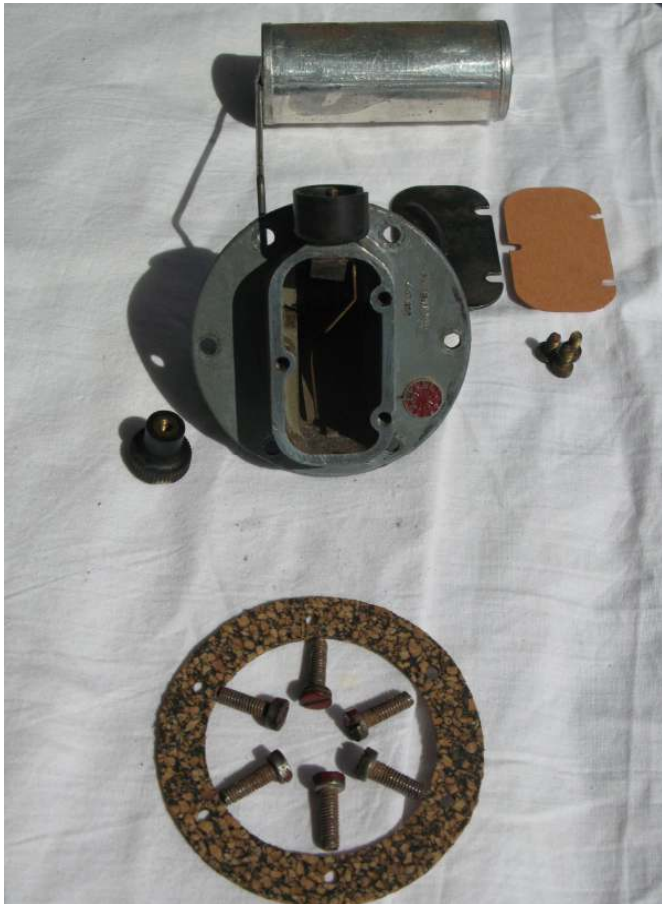
#### View of dismantled fuel sender unit

Components include:

- Float cylinder and wire lever activating arm.

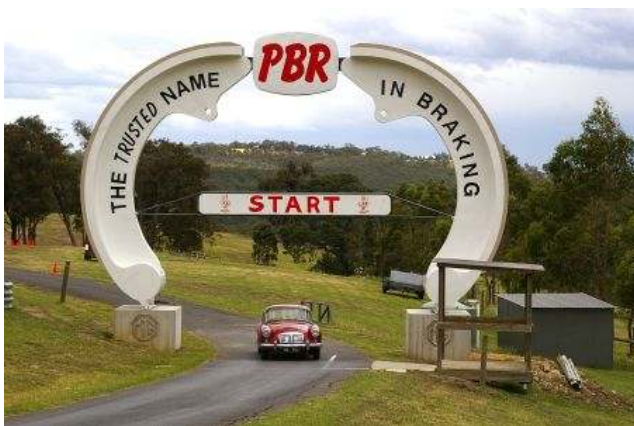
**The giant pair of PBR brake shoes erected just before the start line of the Rob Roy Hillclimb.**

The structure is approximately 32 feet high and weighs 3 ½ tons. It was constructed from 6ft by 4ft sheets of plate steel, welded together and cut to

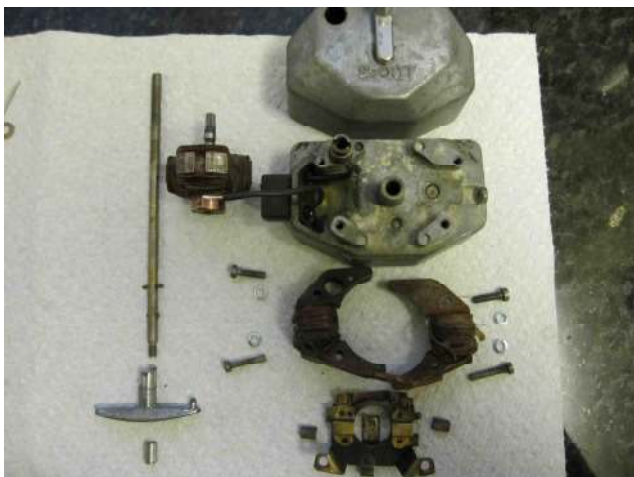
**Photo 1 – Exploded view of motor.**

1. Remove screw from handle, pull handle back and out.
2. Remove two cover holding screws and pull off cover.
3. Noting that each solder connection has two tags, one to grip the wire and the other to solder it, ease each gripping tag open, including the single tag supporting the thin connecting wire between the two stator sections (stator = the two fixed plates on each side of the rotating armature = rotor).
4. Unsolder the two black wires leading from the inside of the connector block where they connect to the brass frame holding the two brushes.
5. Unsolder the thin wire to/from the stator where it is soldered to the same frame as 3 above.

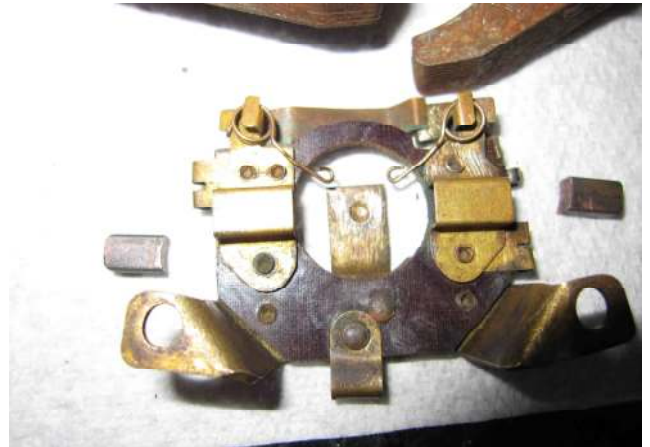
6. Move each brush spring back out of the slot and push aside (photo 2). Remove each brush but carefully note side and orientation of each as they are mounted off-centre and need to be a good fit when replaced.

**Photo 2 – Brush holding plate.**

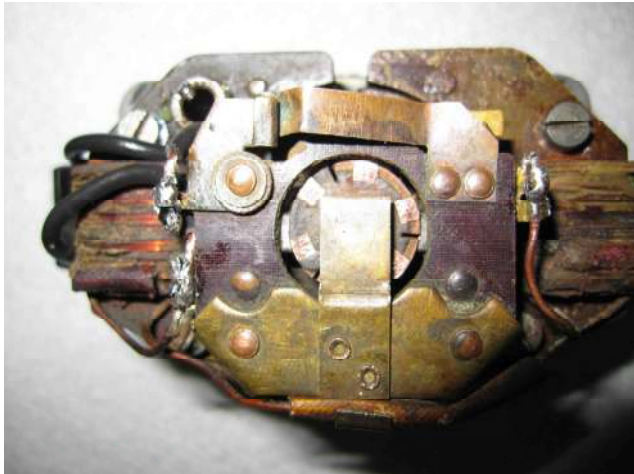
17. (Optional depending on condition of the two side feed wires) Unsolder the two side feed wires and replace with new wire of similar grade and length.
18. Screw plate back on to wiper body.
19. Replace brushes exactly as they came out, then release the holding springs back into their slots.
20. Re-solder all connections (photo 3).

**Photo 3 – Soldering completed.**

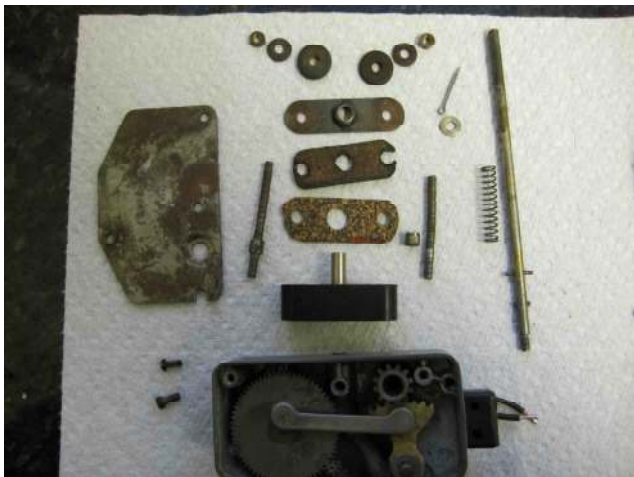
**Photo 4 – Exploded view of Front (Gearbox side).**

23. Remove both motor mounting studs by locking two brass nut together then unscrewing.
24. Lift off 1/2" spacer.
25. Unscrew two cover locking screws. Prise off cover, possibly using a small screwdriver in the U-shaped slot at top right if tight.
26. Note that the smallest gear, which extends into the rear section, has a small dimple in the inner ring (photo 5). This must align with the

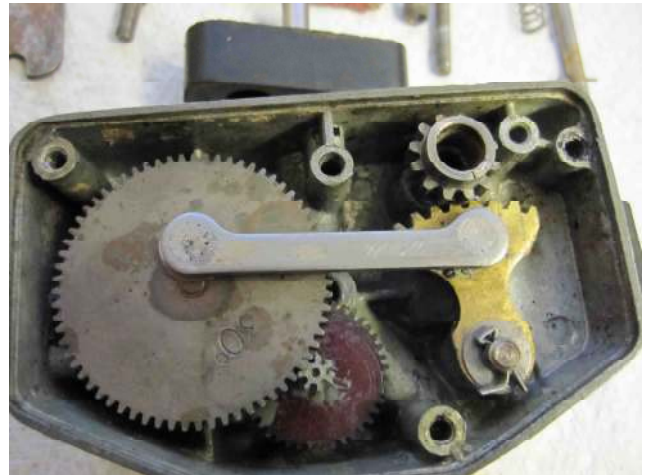
centre of the brass quadrant gear in re-assembly. Orientation does not matter anywhere else in the gearbox.

**Photo 5 – Gearbox detail.**

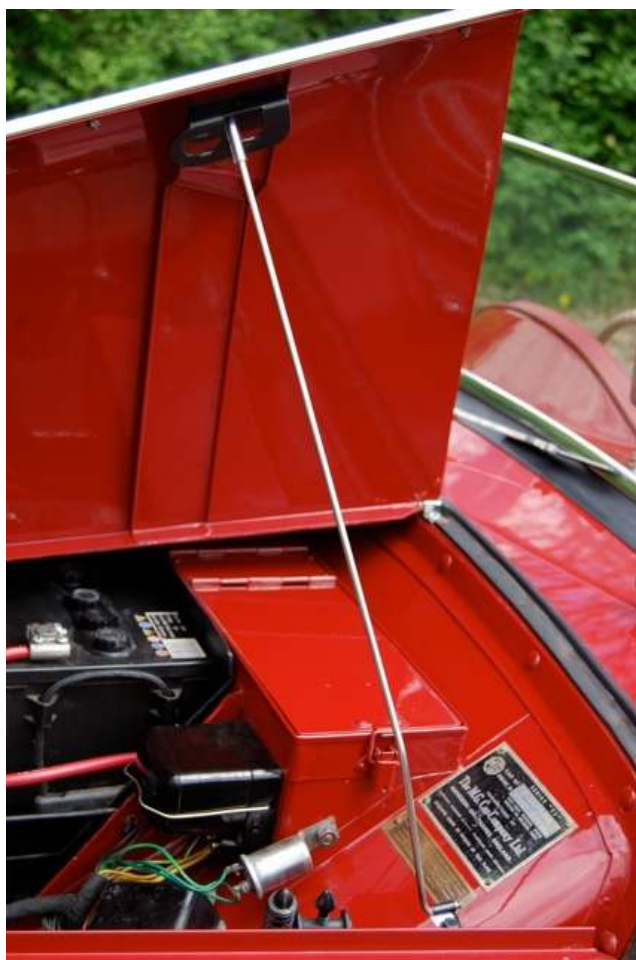
**Photo 1 – showing method of fixing**

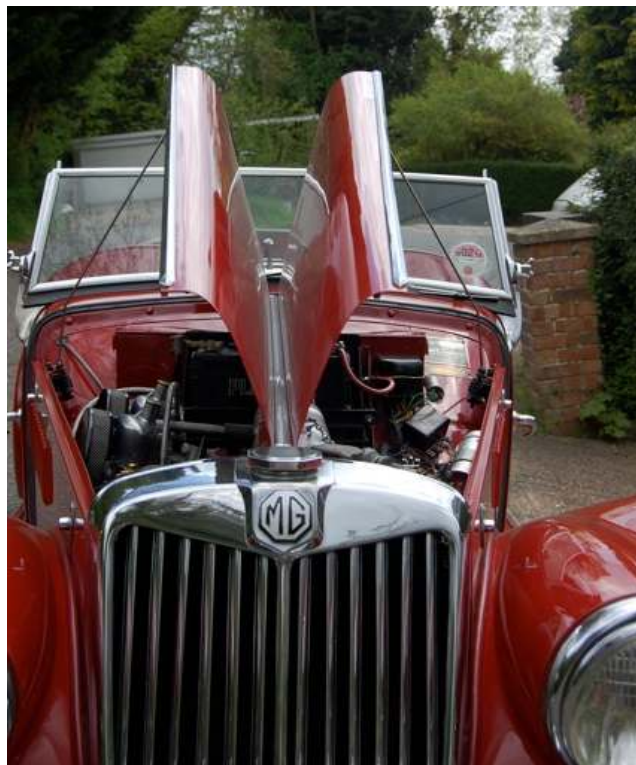
**Photo 2 – showing both bonnet tops raised.**

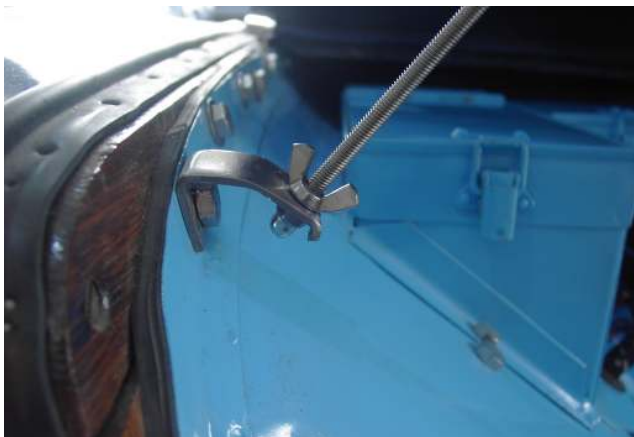
Photos 4 & 5 showing bracket on bulkhead and method of fixing.

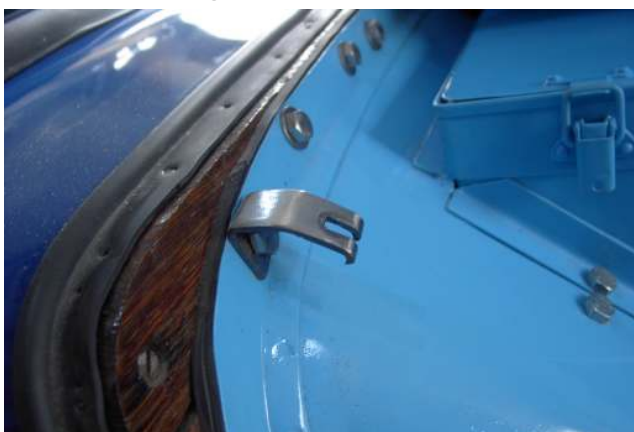
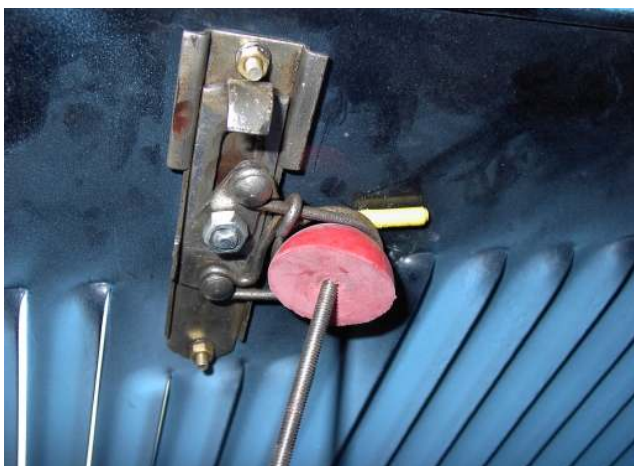
Photo 6 – a rubber ball cut in half makes a useful “cushion” against the locating point on the bonnet side.

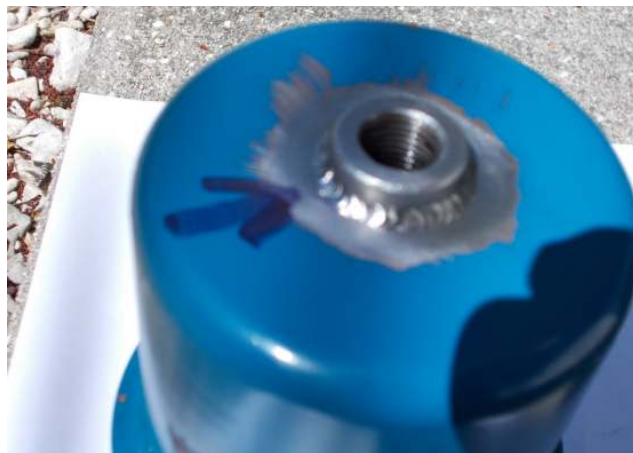
For a while now I have had a niggly wee oil leak.... nothing serious and I thought it was just a blow-back from the front end. However I had a close look and discovered that there was oil gathering on top of the filter. I cleaned it off and then started the engine to see if anything happened; sure enough, a little seepage of oil from just under the pipe connection. I changed the copper gaskets - no difference, so I removed the filter and cleaned off the paint in the offending area. The weld looked well done with no apparent flaws – however, when I pressurised the canister, there was a leakage around about a third of the weld where it met the canister top! Otherwise it was invisible to the naked eye.

Here is a pic - sorry it is a bit out of focus, I cannot go back and retake it, as it is now all re-welded, and repaired. The arrow shows where it was leaking. I am glad I found this in the garage and not out on the open road where it could have got much worse. Maybe you should just check yours too? Cheers!

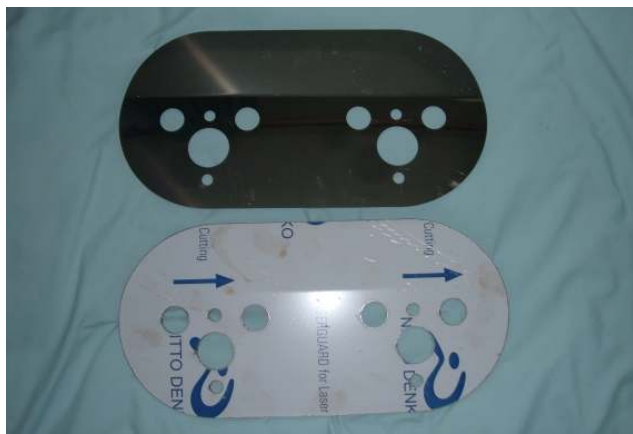
I now have some more in stock (top heat shield in the photo is for a TF, bottom is for a TB/TC, with protective wrapping in place to keep the stainless steel unmarked prior to fitting). Price is £15 plus postage at cost. They will not fit if you have a 5-speed 'box as the engine will have been moved forward. The TC requires spacers and these can be supplied in aluminium at £5 each. Slightly longer studs are also required for the TB/TC as a result of fitting the spacers but I do not currently supply these.
